Receiver 01 Re-calibration

Nivedita Mahesh , Raul Monsalve, Leroy Johnson

The receiver01 that was connected to the midband system was back from the site in MArch 2019. The receiver was recalibrated to make sure the coefficients had not changed during the data collection period. This was done as a verification as the midband data is currently being analysed.

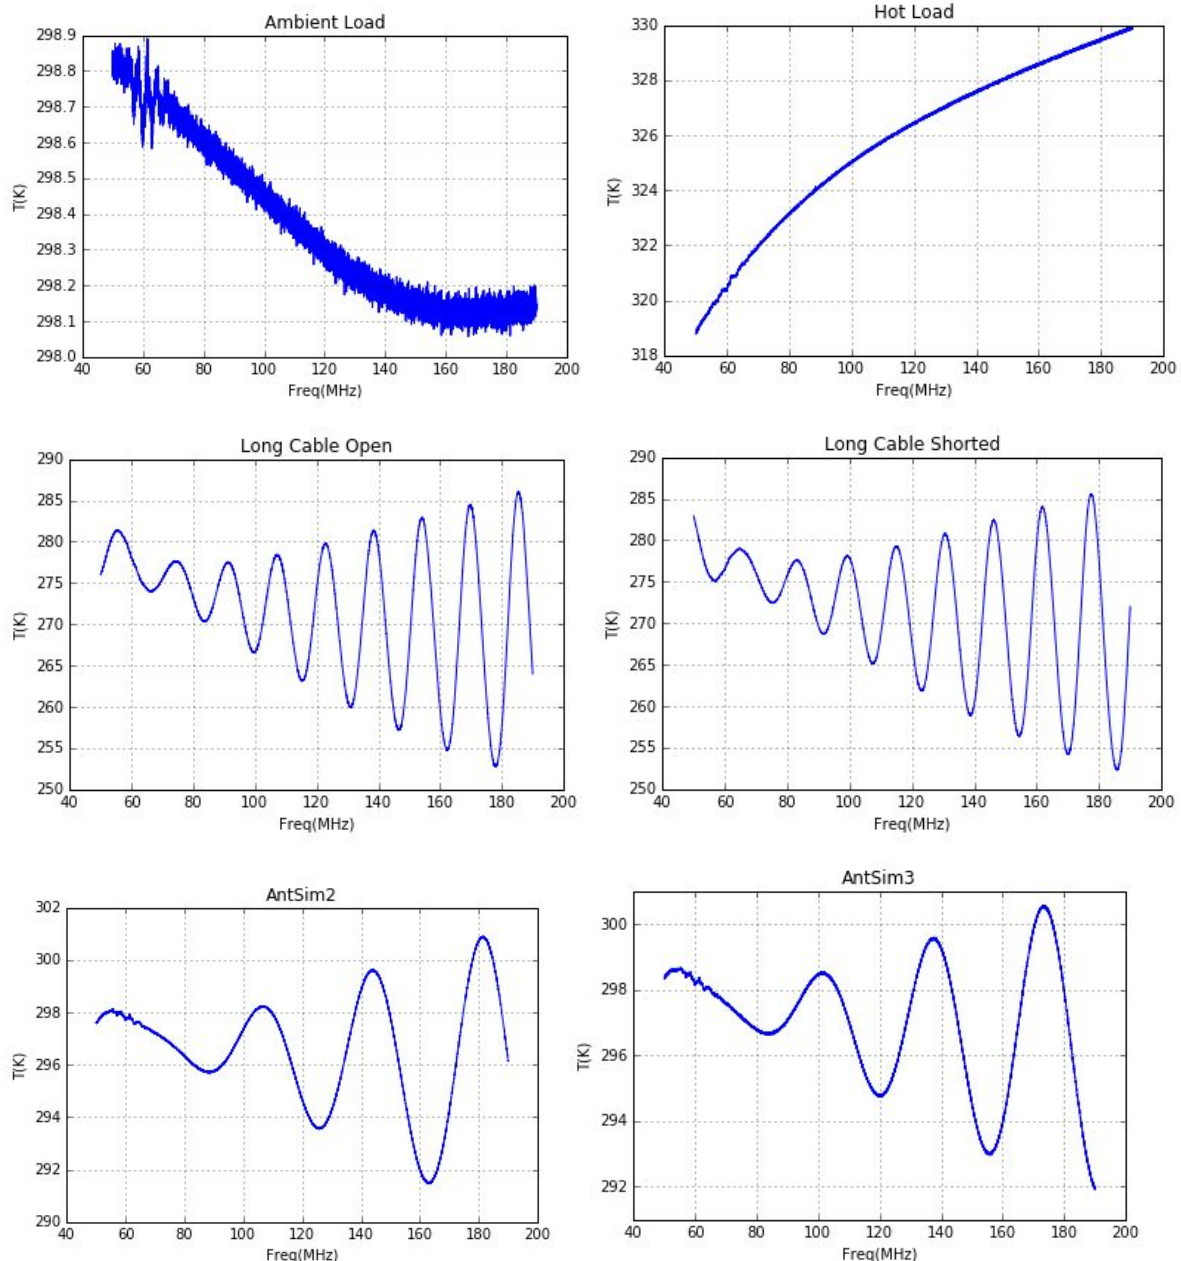
On looking at the individual load spectra, A ripple was seen around 60 MHz.

Figure1: Uncalibrated spectra vs Freq of the individual standard loads collected with Rcv#1 and backend A. The ripple is present in all the spectra. In the cable spectra it is not quite visible just because of the wide range of the scale.

The whole measurement was redone. The spectra was recollected by switching the backend to the one that is usually used in the Lab (backend B). **File: Receiver1_25C_2019_04_10_040_to_200_MHz/25C.** The Spectra of the individual loads are shown below:

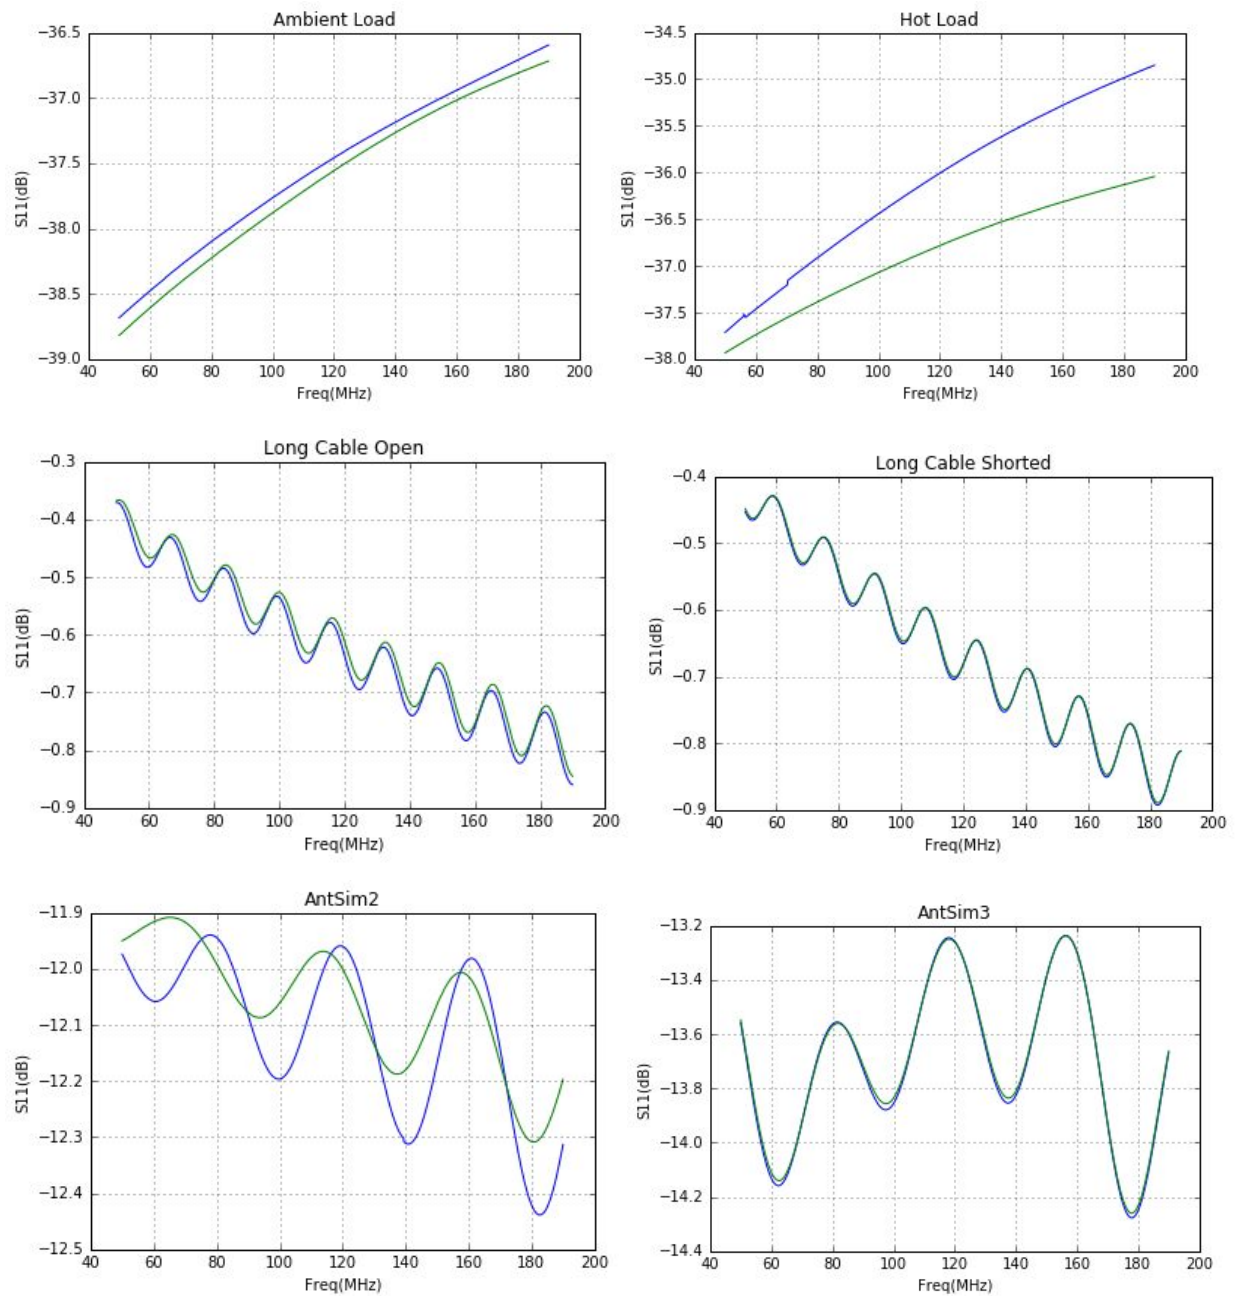
Figure2: S11 Vs Freq for all the loads. The two curves in each plot corresponds to the two repeats of the same measurement.

It can be seen from the above plots that the two measurements of the Hot load and the Antsim2 did not match.

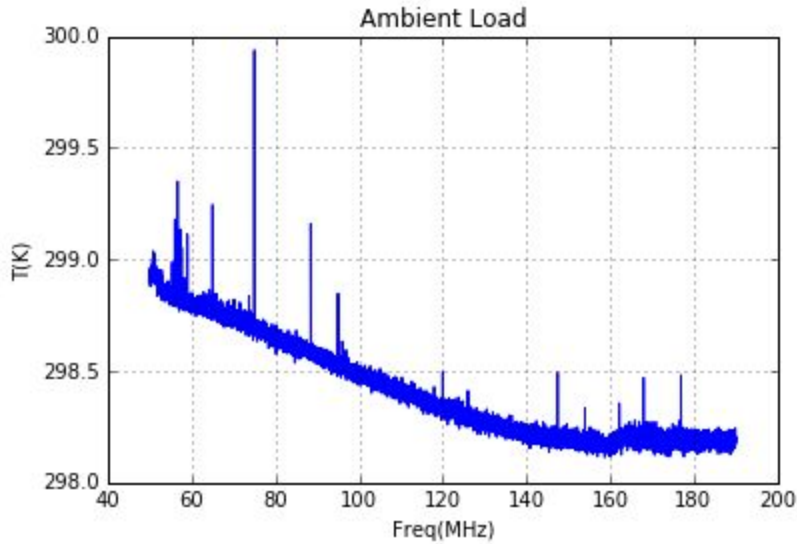
Figure3: Uncalibrated spectra vs Freq for the ambient load collected with Rcv #1 and the backend B.

There is too much RFI. Two days of spectra was collected and the RFI is seen in both the individual spectra. But on zooming in, there is no evidence of the 60 MHz ripple:

The RFI was due to the improper connection between the load box and receiver via the SMA connected. This was fixed and the raw spectra looks clean as shown below:

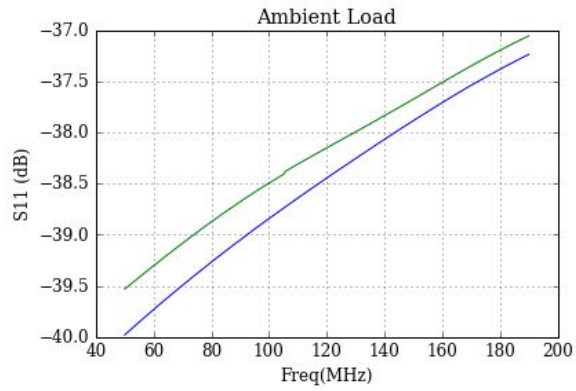
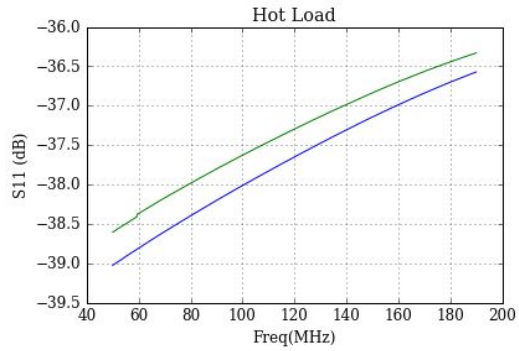
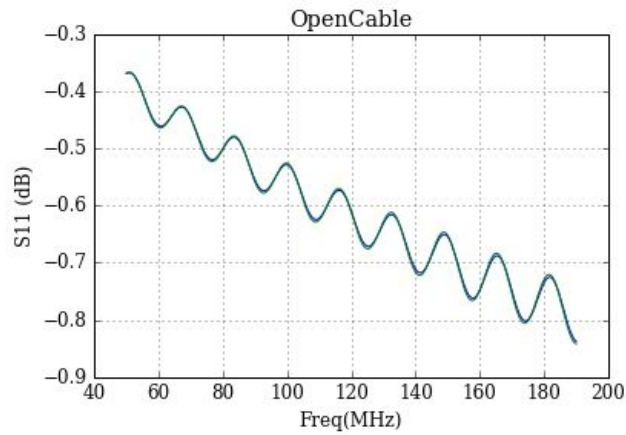
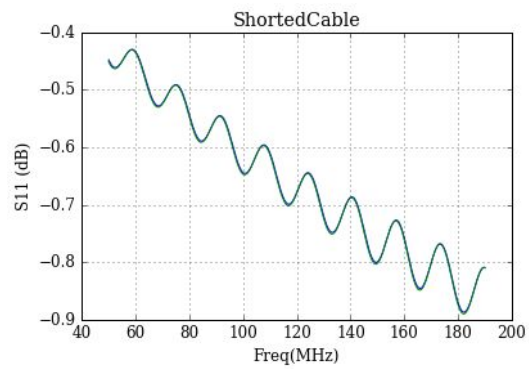
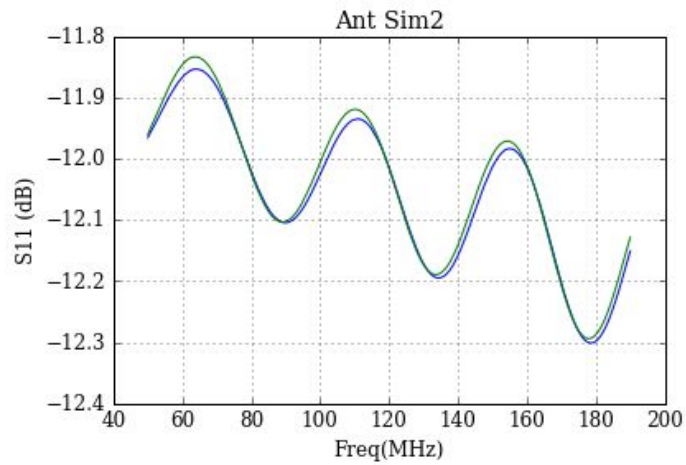
The S11 was also inspected and they looked consistent between the two individual repeats for each load.

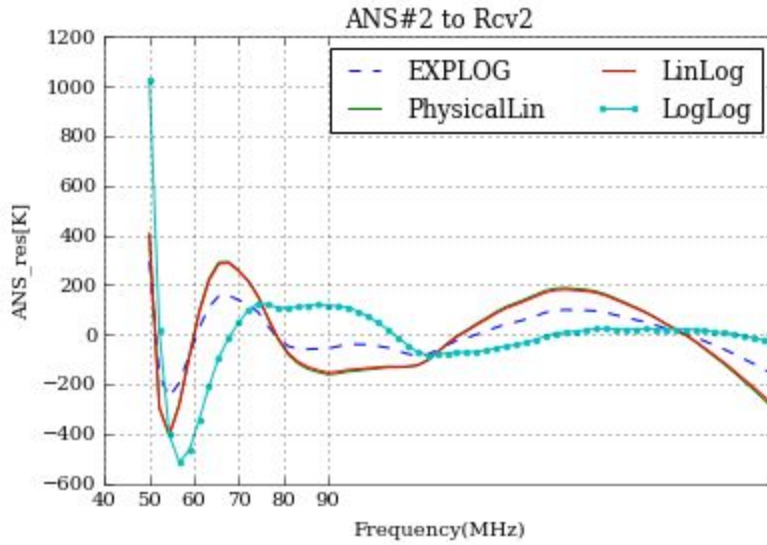
The ANS spectra collected with rcv2 was calibrated using the cal coefficients from 2018. And the residues to the calibrated spectra is plotted below. No ripple is seen but the residues are high indicating a 6dB attenuator was not used for this measurement.

To solve the 60 MHz ripple issue with back end A, we reconnected Back end A and obtained the ANS spectra with RCV01 & RCV02. The attenuator on the backend was tightened for this measurement. Expecting no ripple.
