ARIZONA STATE UNIVERSITY  
TEMPE, ARIZONA 85287

**Jaime's payload deployer hinge design testing**

Mickey Horn  
10/15/2020

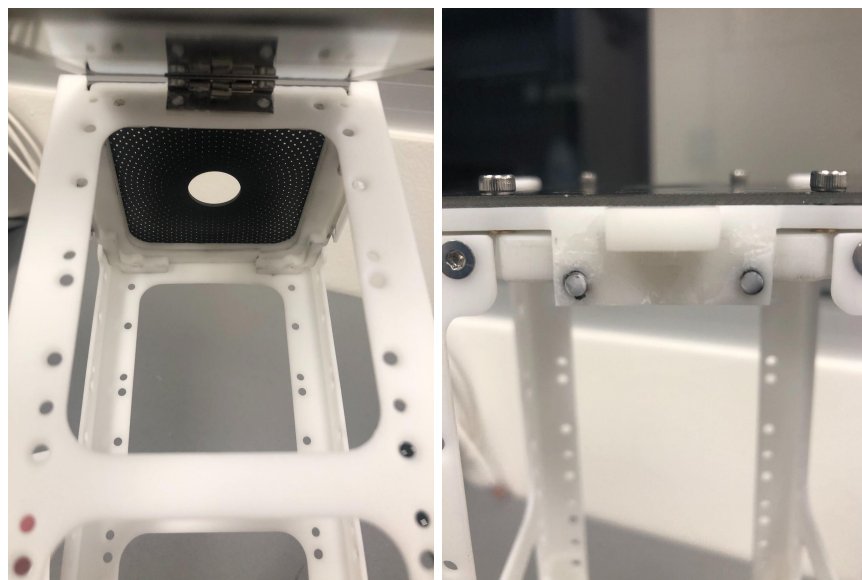
Hinge A, on the other hand, had quite a hiccup. On my 4th trial, the hinge and panel completely separated from the bus structure once I released it. This would obviously be a critical error in our operations. However, the hinge was not secured to the bus structure very well. It was basically just resting on a couple of protrusions and not secured down. I think this should be retested with the hinges actually bolted into place, so that we can evaluate if this will happen under real conditions.

**Figure 2:** *Left:* hinge attached to plastic pegs. *Right:* plastic pegs where the hinge was separated.
