# Receiver 03 - Ripple analysis

Leroy Johnson, Nivedita Mahesh  
ASU

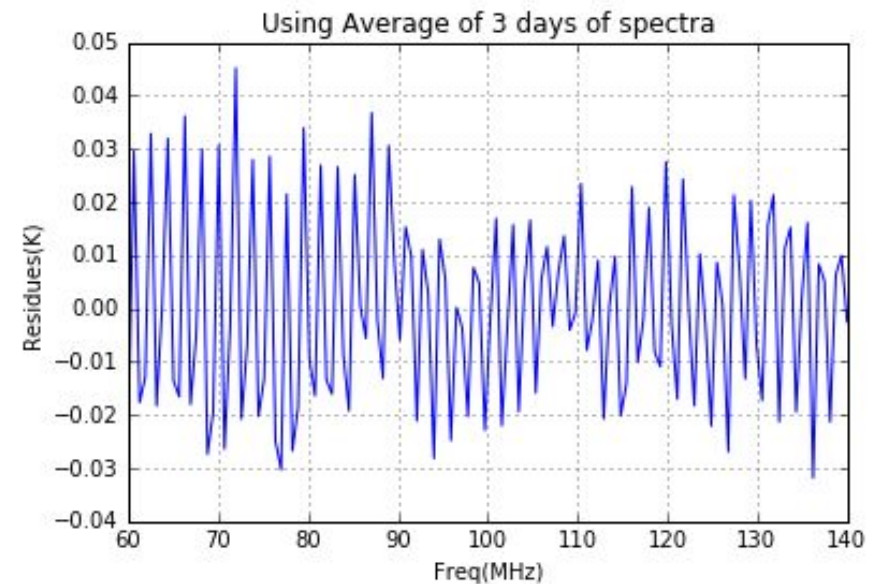
- Ripples in the data from receiver 03 was noted in the field itself.
  - Period - 1.7MHz
- We tested the receiver in the lab by connecting a 6dB attenuator and looking at the spectra.
- Average of 3 days of spectra was used.
- The period of ripples that I calculated from the residues is 1.88MHz.
- Given the velocity of propagation of LMR 400 to be 85%.  $\Rightarrow$  cable length =  $135\text{m}/2 \sim 67\text{m}$ .
- In the lab we used a "50m" cable.

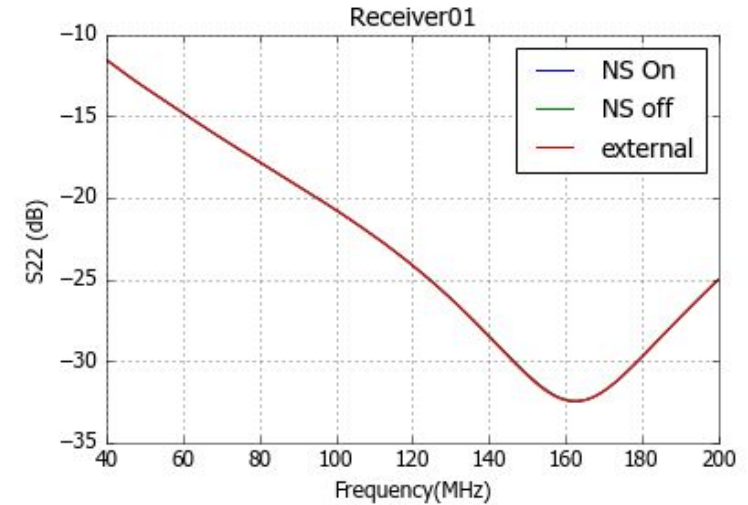
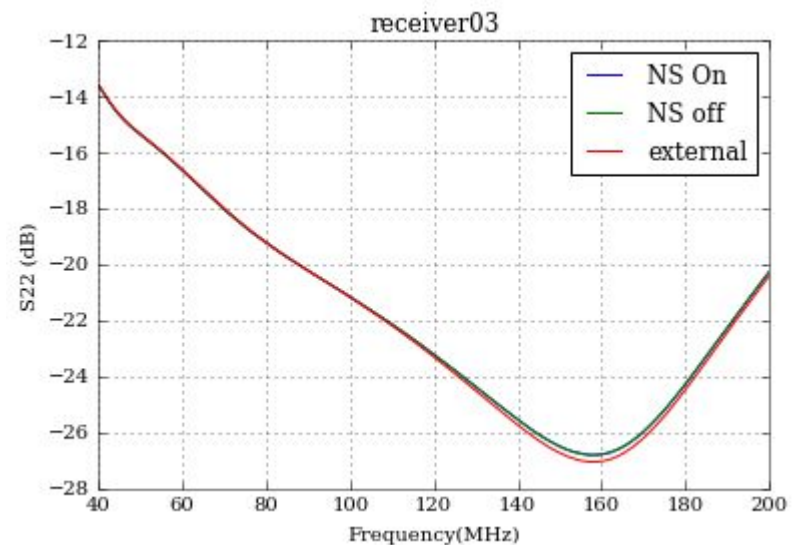
- A 6dB attenuator was connected to the input of the receiver.
  - VNA was connected to the LNA output.
  - The S11 was measured for all three LNA switch positions
  - A bias-tee was used between the receiver and the VNA to provide a voltage to the receiver to change the switch state.
  - The same was done for Receiver01 to understand the differences.
- 
- S22 of the three switch positions are shown for both the receivers.

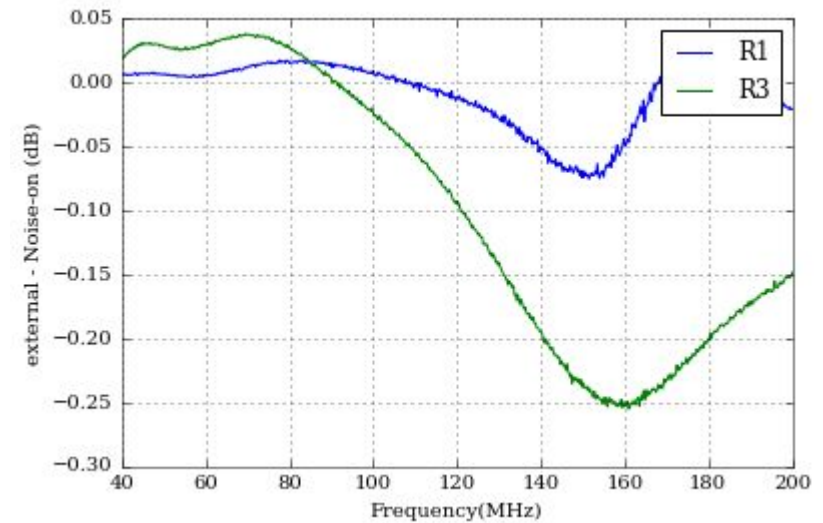
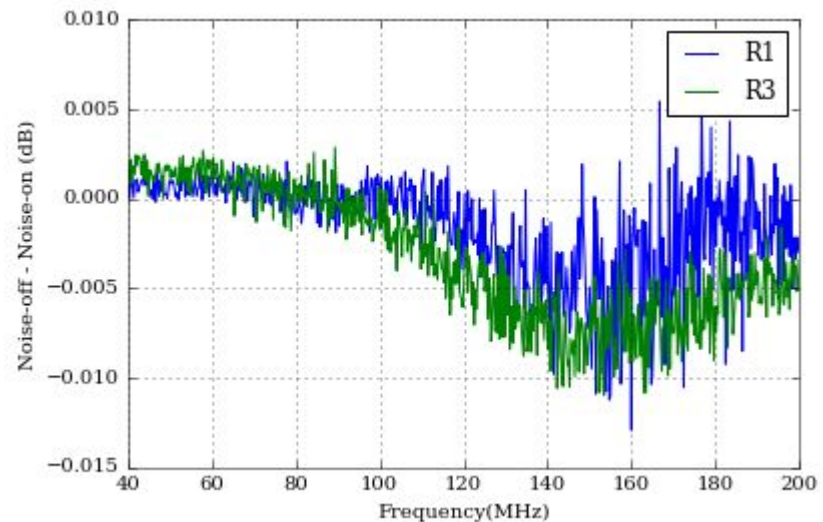
- Difference in the S22 between the Switch position 1 & 2 for both receiver 01 & receiver03
- Difference in the S22 between the Switch position 2 & 3 for both receiver 01 & receiver03

The second plot does suggest the difference in S22 between antenna input and internal noise could be a possible issue. The large-ish difference between switch states would either be: a) an issue with the LNA itself, 2) there isn't enough isolation between the LNA and the output of the receiver (so we could add attenuation somewhere after the LNA) or 3) the bias-tee is having troubles still.

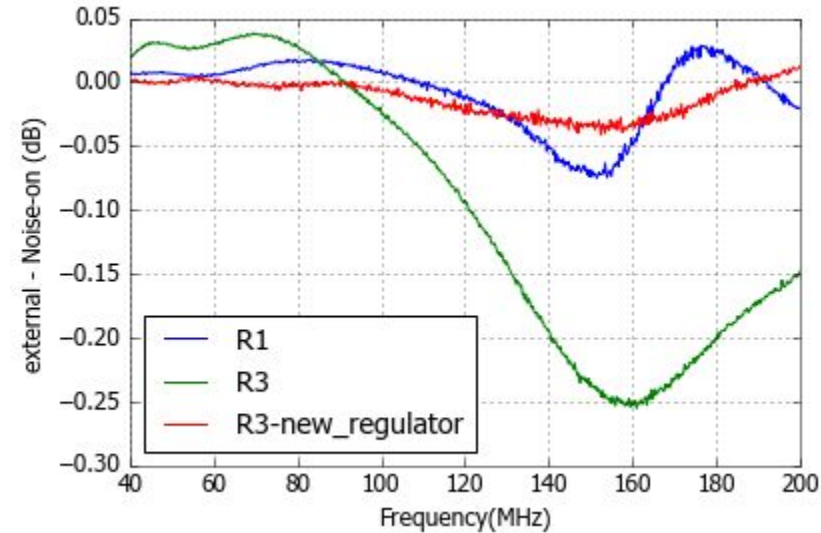
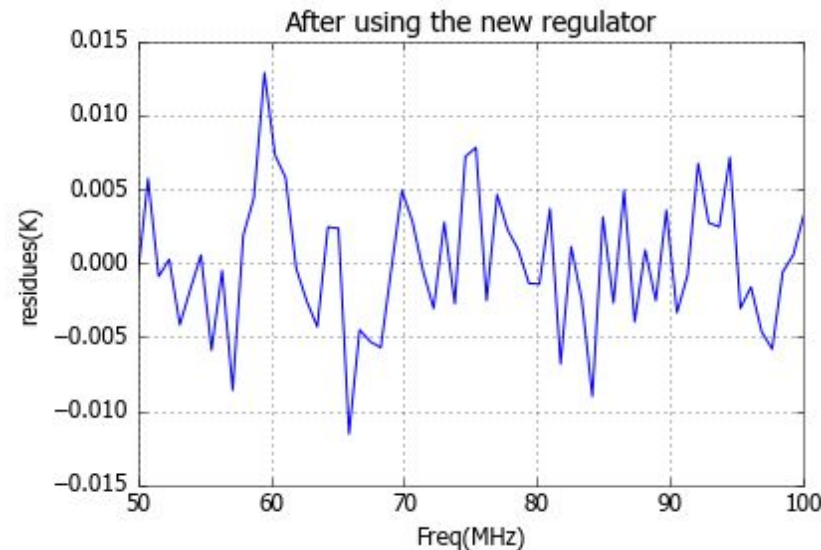
Leroy noticed the issue that when trying to switch to the external position; it would not engage. The SPDT switch pertaining to the noise source was shorting to ground

- A new regulator for the external noise source was installed Lm7812ct (old part number Lm7815ct).
- A capacitor was placed on the bias-Tee.
- S22 was measured again and shown in the top right plot is the difference between the external antenna position and Noise position.
- The difference reduced and is now similar to that of receiver 01.
- Spectra with 6dB connected to the receiver taken again.
- Average of 4 days of spectra was used.
- A fourier series of 7 terms was fitted to the data between 50 - 100 MHz and the residues are shown in the bottom plot.
